Accountability Report

Facilities

Mike Hurd, Superintendent of Facilities

March 18, 2024

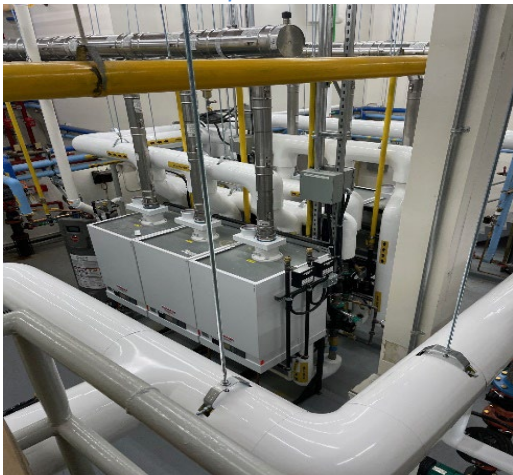
Riverside boiler replacement

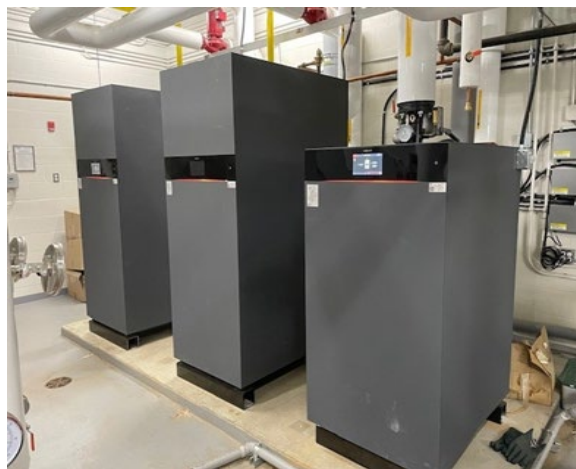
CPAC boiler replacement
